**Flood Control Project Maintenance
Levee Inspections**

Fall 2015 Levee Maintenance Deficiency Summary Report

San Joaquin River Basin

Reclamation District No. 2094 Wathal

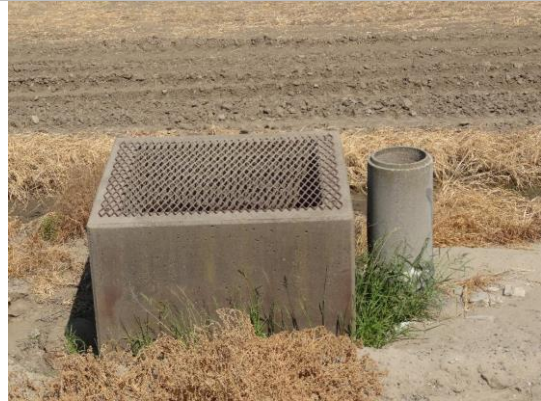
Photo 2 of 3 : UCIP_FA_2015_1797.jpg

LM Start	2.45	Rating **	M	Issue No.	16 (cont)
LM End	2.45	Issue Type +	En	Location *	WS
Category	Supplemental			GPS Latitude/Longitude	
				Start	End
Item	DWR UCIP Field Study			37.752308 °	37.752308 °
				-121.293191 °	-121.293191 °
DWR ID					
Action/Comments					
Inspector Comments: FS_ID:21545 DS_ID:23089 EP_NO: N/A FS_HLM: 2.488 Repair Type: Non-Urgent Crossing Status: Found UCIP Comments: - no pipes found on either side of the levee.- concrete distribution box on LS. Soil erosion around distrinution box. FIELD_STRUCT_DESC: Rectangular concrete distribution box on the landward toe FS Date: 09/10/2013
